## Memorandum

Subject: Summary of Creek Investigations Completed for Libby Asbestos  
Superfund Site Operable Units 4 and 7, October 2008

OU4 Creek Investigations  
Libby Asbestos Site  
Libby, Montana

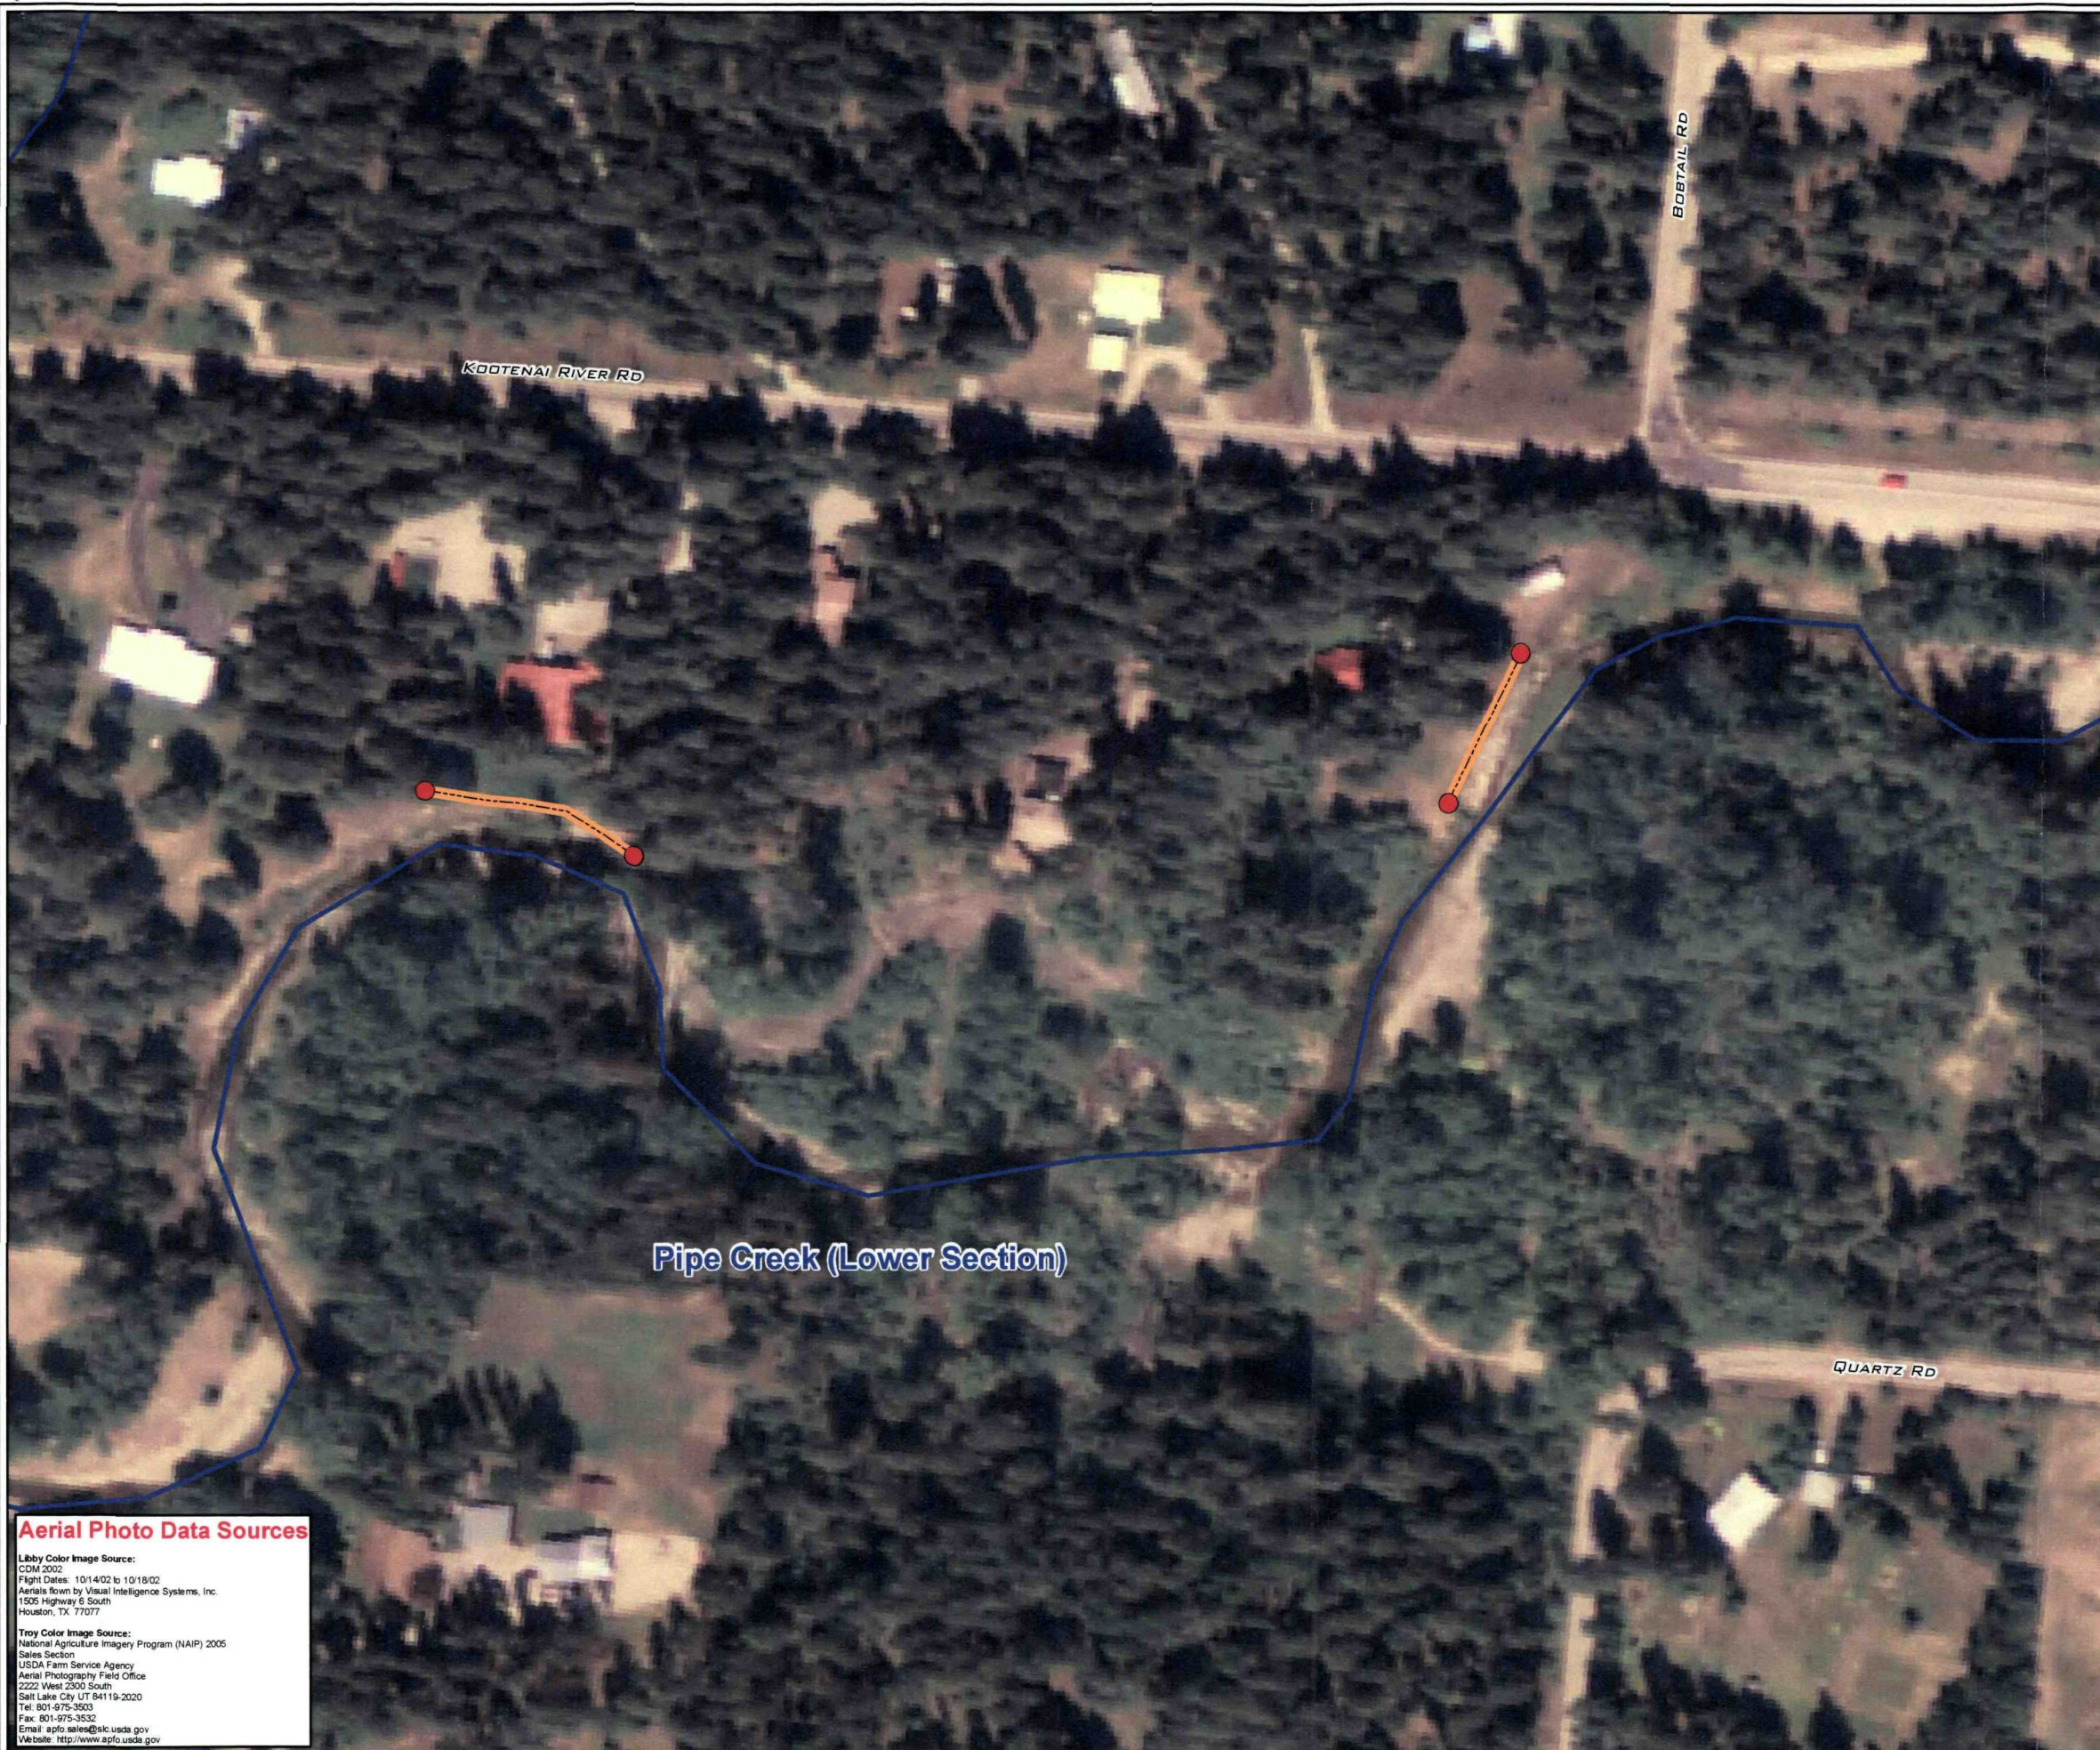
| Figure 3 |

A 1-mile section of Pipe Cr, beginning at the Kootenai River, was investigated on October 13, 2008 (Figure 1). Riprap material in this section of Pipe Cr is composed of metasediments and basalt except for riprap located at two residential properties on the northern bank of Pipe Cr, between Kootenai River Rd and Botham Drive (Figure 3).

Riprap located on both of these properties is composed of quarried syenite and a smaller volume of metasediments ranging in size from cobbles to boulders. The largest pieces of syenite are approximately 3 feet (ft) in length, averaging approximately 18 inches (in). The syenite locally contains LA material as fracture coatings on syenite. The fracture coatings are the most prevalent form and appear as small radiating, fibrous aggregates, light blue-gray to dull silver in color, similar to LA material observed in Libby Cr.

The riprap at 3623 Kootenai River Rd (PC-01 to PC-02) was placed in a curved, linear exposure (10 ft in total lateral extent) and is approximately 200 ft in length. The riprap at 3737 Kootenai River Rd (PC-03 to PC-04) has similar placement and is approximately 300 ft in length. The riprap at both locations is weathered and often discontinuous with indications of downstream mobilization of components due to erosion.

Field sketches of cross-sections of these two locations were not created due to the inconsistent and discontinuous distribution of the material. Further survey activities may be required to fully detail the physical layout of these sections of rip-rap.

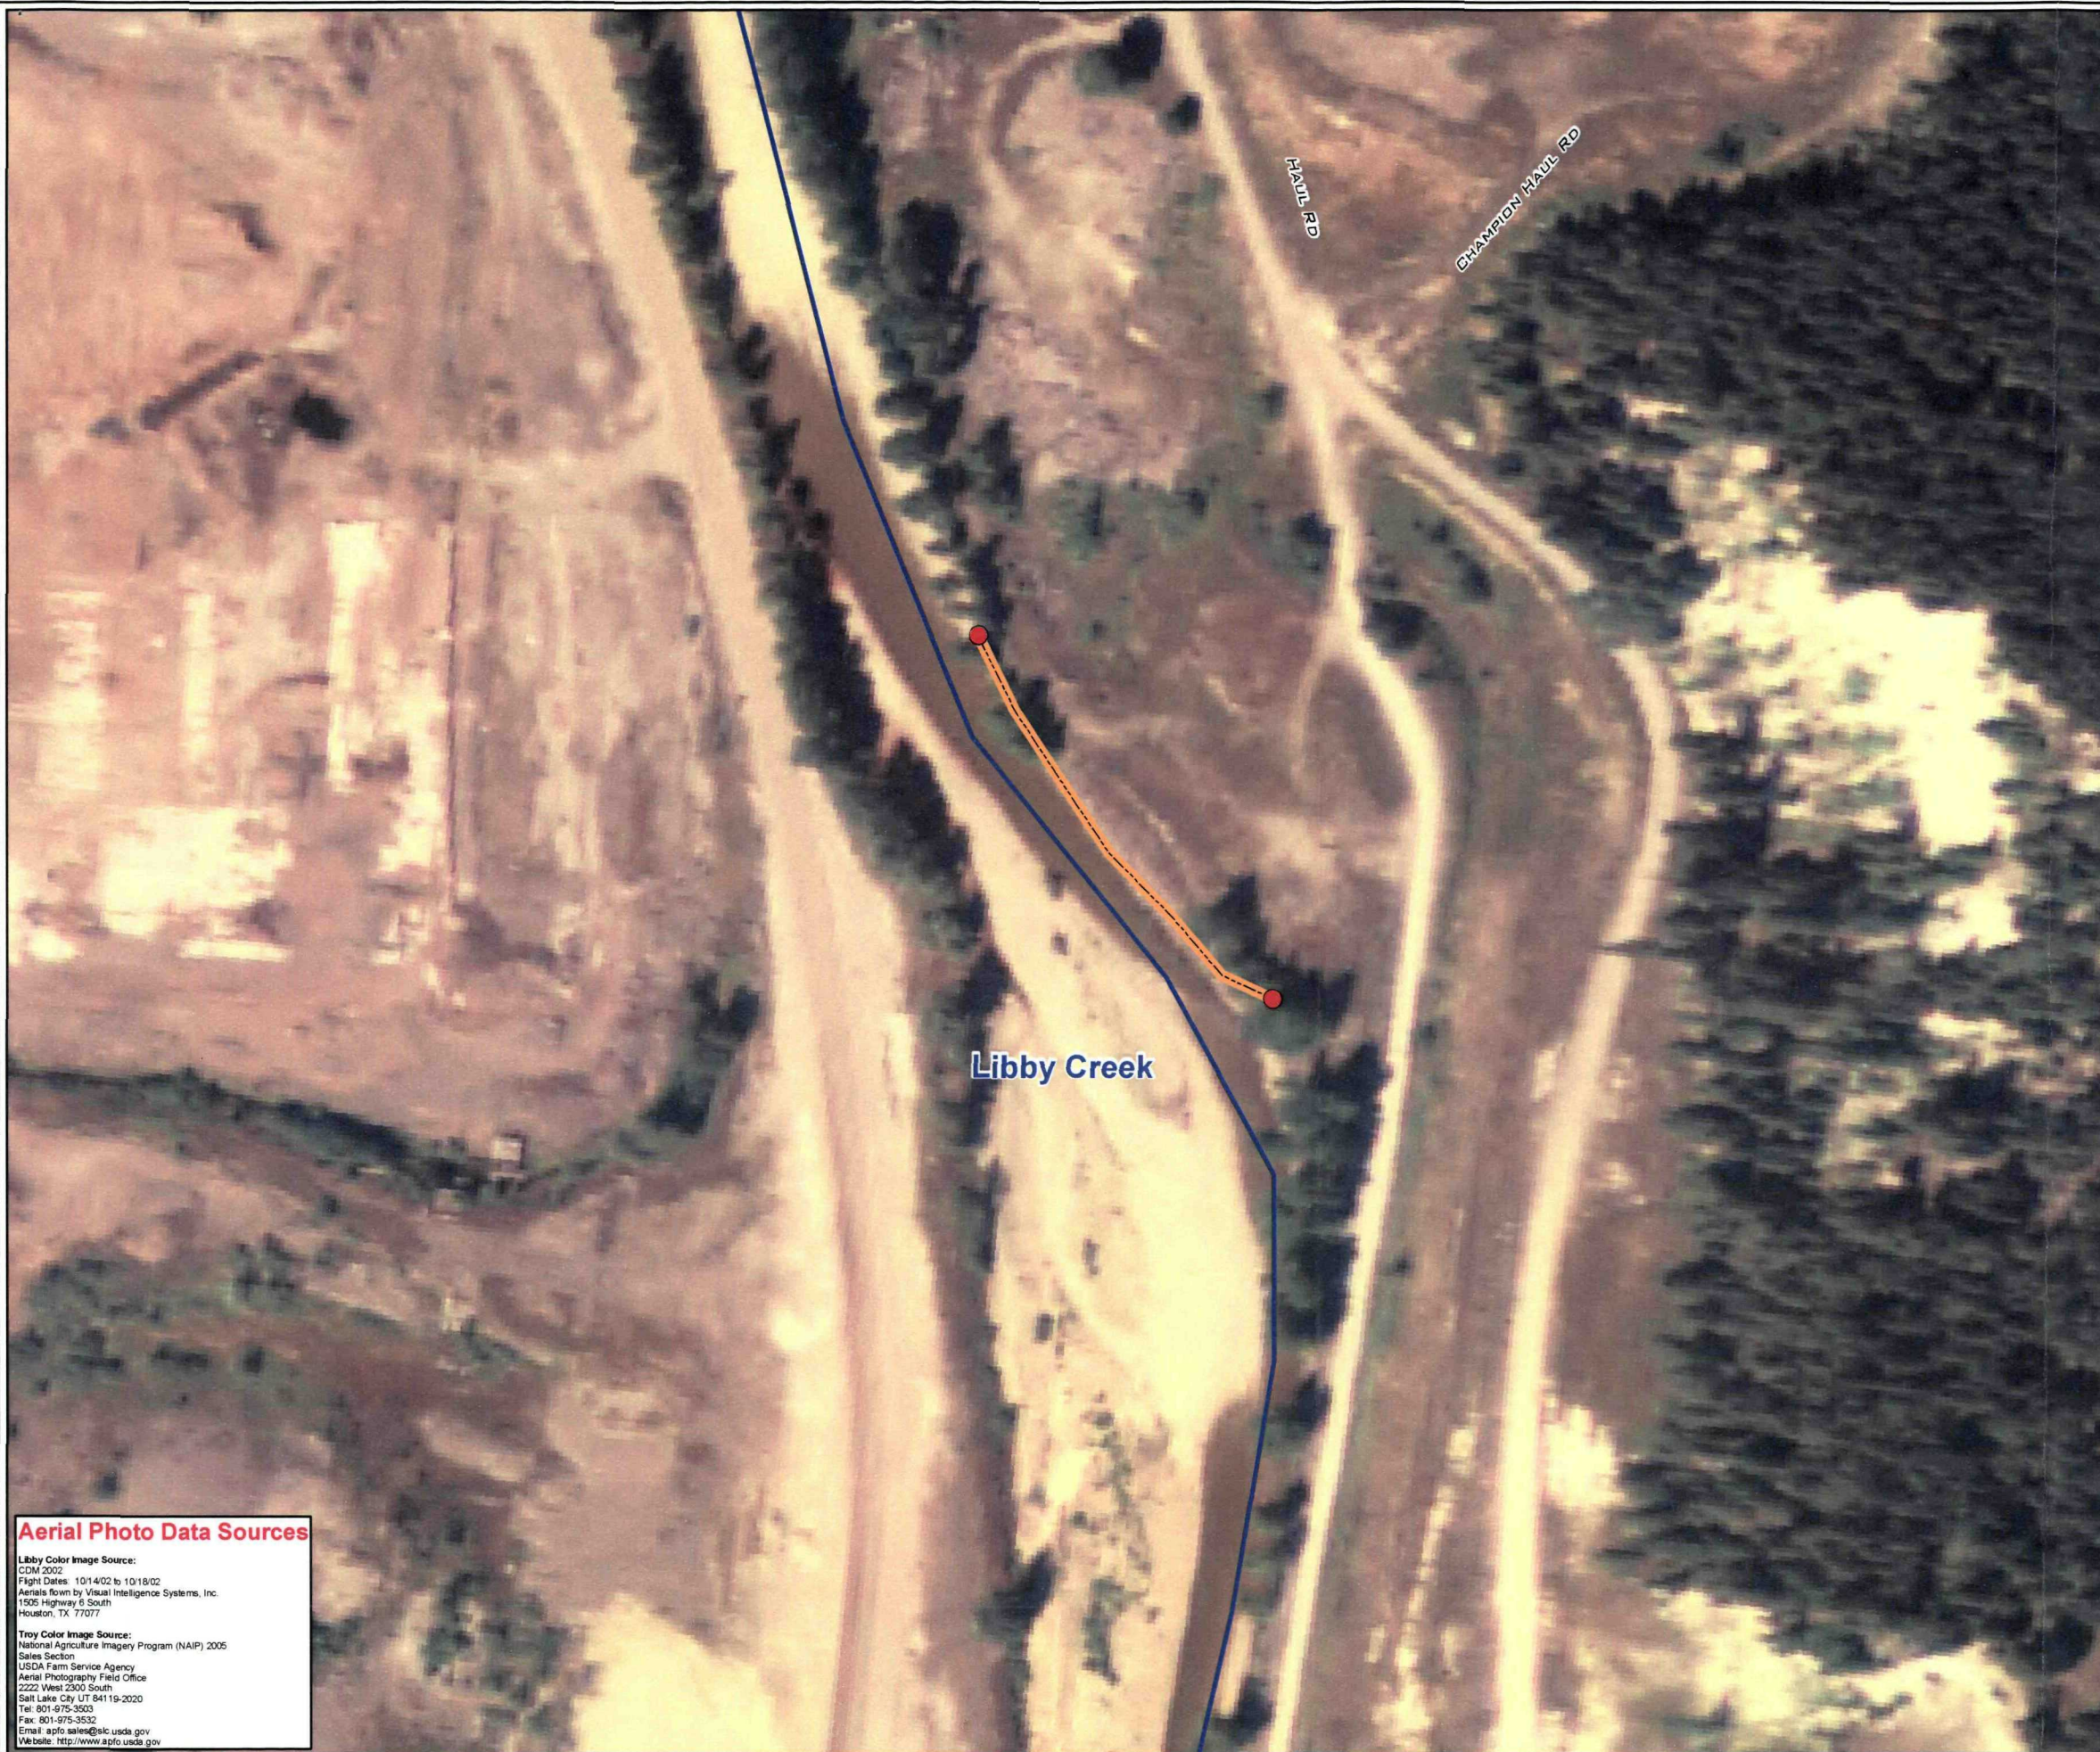
Figure 4

A 6.7-mile section of Libby Cr, extending from the Kootenai River to near Farm to Market Road (F-M Rd) on the south end of the section was investigated on October 9, October 10, and October 20, 2008 (Figure 1). All riprap material in this section of Libby Cr is composed of metasediments, basalt, and concrete debris, except for a small exposure of riprap located on the eastern bank of the creek, approximately 700 ft south of the Champion Haul Rd bridge (Figure 4).

This riprap section (LC-01 to LC-02) is composed of quarried syenite. The largest pieces are approximately 3 ft in length, averaging approximately 18 in. The syenite locally contains weathered xenoliths of magnetite pyroxenite and biotite pyroxenite. LA material is present in this riprap, and occurs most commonly as fracture coatings on syenite. The fracture coatings appear as small radiating, fibrous aggregates that are light blue-gray to dull silver in color. The LA is soft and has been weathered.

The riprap at this section was placed in a linear exposure (15 ft in lateral extent) and is approximately 300 ft in length. This riprap was deposited in layers. The bottom of the syenite layer (approximately 5 ft height) occurs near the water line and is covered by a 5-ft layer of basalt. The riprap is consolidated with no obvious indication of downstream mobilization of large components due to erosion.

A field sketch of the cross-section at this location was created in the field log notes and is available upon request. Further survey activities may be required to fully detail the physical layout of these sections of rip-rap.
